## تحسين اغشية الايبوكسي الرقيقة المستخدمة في طلاء ركائز الألمنيوم بواسطة التسخين الومضي وتطبيقاتها كمادة عازلة مقاومة للتآكل

الاستاذة بأن وليد محمد

وزارة النفط العراقية – شركة النفط الوطنية – شركة نفط البصرة

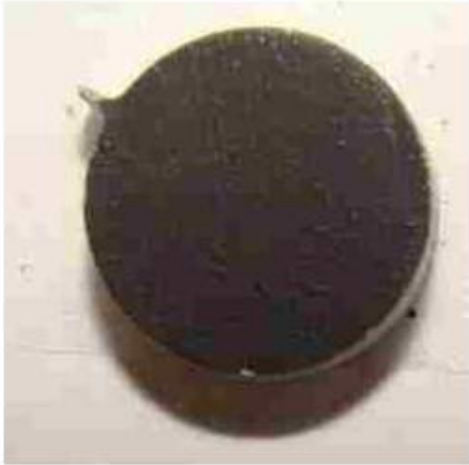
**Figure 2-1: : Burn Epoxy Film Used to confirm testing and recording devices**

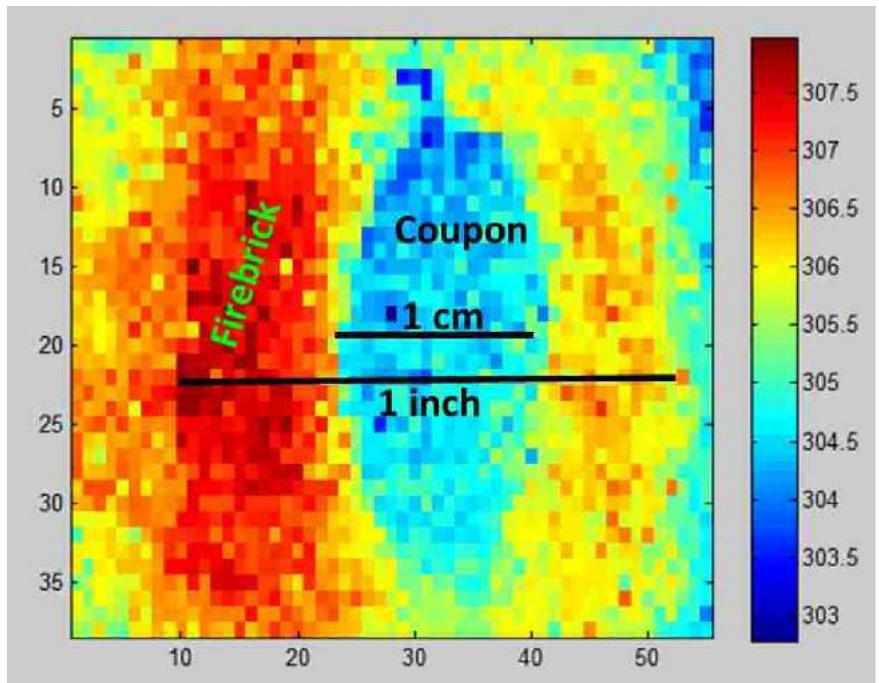
a far better"> a far higher temperature because of the previous smoke kept from flammable cups turning it into a dark, extended digestion. Inside the warm camera traces inside the front, coupons appear oval because the camera has been precisely adjusted. In any event, the data

**Figure 2-5: In the front laser initiation image, the thermal camera shows a laser diameter of 1 inch and firebrick does not carry heat to or from the coupon.**

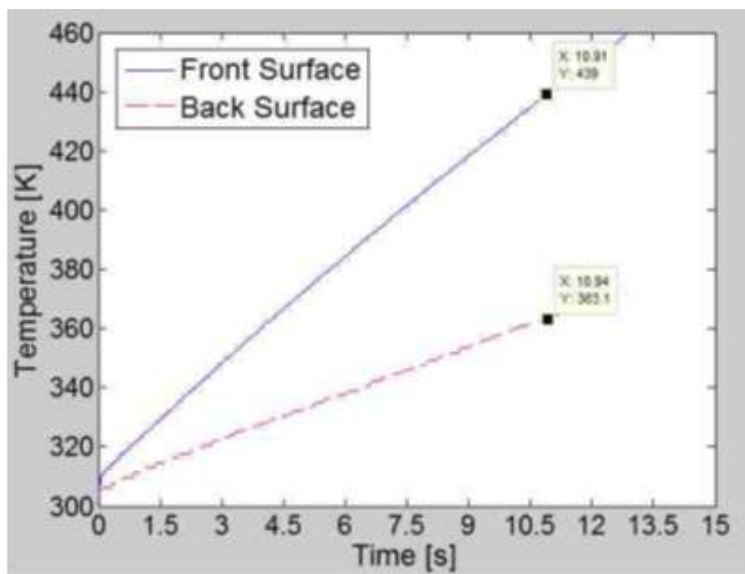
**Figure 3–7: Primary surface and aluminum surface temperature profiles of epoxy polyamide 2024-T4. Power incident 18 W/cm<sup>2</sup>, time 10.9s and total exposure to degradation 12.8s.**

The temperature profile for the total warm camera recorder, the times for the primary obvious smoke, the total time of the Xenon Streak Light streaking stream and the area of the coupon in relation to Pixel records for the string warming effort were given in all past stages of post-planing the data. In order to synchronize temperature and video data, the video diagram must be linked to warm camera diagrams. This is characterized by an increase in the string Figure 3-7 shows the temperature on the front surface.

50 tracks per minute. The start and wrap centers inside the figures demonstrate a decreased temperature rise as the trade of warm to the back surface (around direct rise in the back surface to a lower temperature in the same entirety).

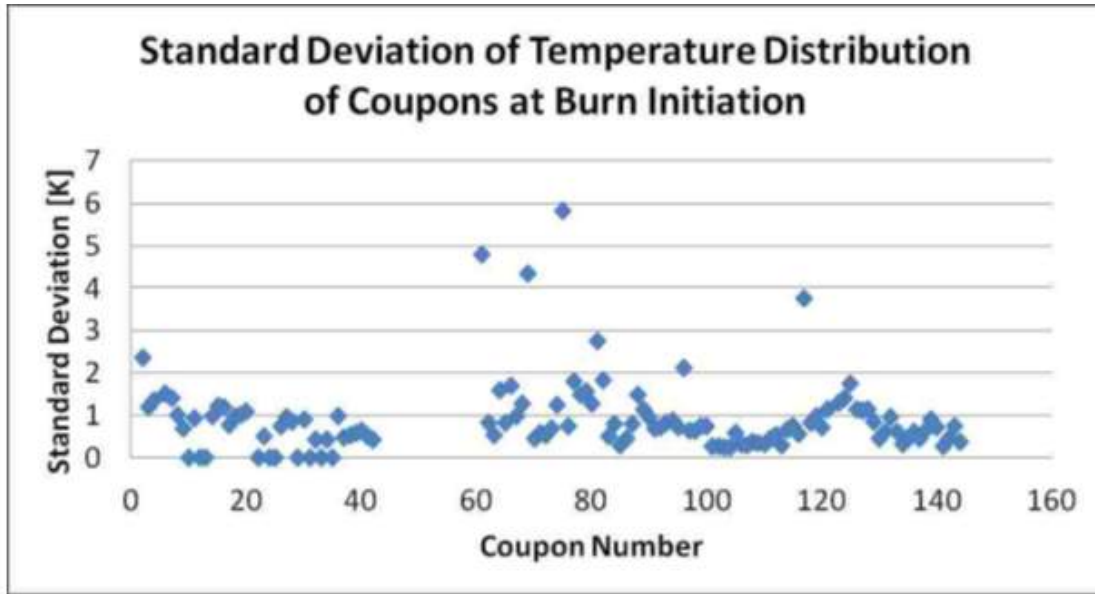
Figure 4-1: Standard Deviation of All Pixels on Coupon Surface at Frame of Burn Initiation

Its spread for the coupon in the midst of warm stacking associated with the Xenon streak light is principal. This was since the estimations for the cruel temperatures of the coupon test gauge were calculated utilizing the normal At the beginning of burn, temperature over the surface of each coupon. The standard deviation in the beginning diagram is displayed in figure 4-1. Temperature deviations over the coupons were sufficient to use the temperature as a raw representation of the temperature of the coupon. Other outlines recorded higher deviations in the surface temperature of the coupons. These higher variations in the temperature of the coupon are due to a warm camera that does not perform a warm recording calibration (NUC). A number of these occurred in the middle of the operation, but all NUCs were actually made by hot cameras after the xenon streak light.. The pitiless burn begins at temperature. There does show up to be some gathering of burn start temperature data with respect to the event flux. Real Investigation has been conducted to determine if the burn starts with an increase in temperature, as other epoxy tar considerations (9)(15)(2)(11) or if temperature data are collected shows up a single burn begin temperature.
